**Test Data Report** (extracts, c/w amendments)  
**GA Shuffle-Less Glazing Channel**

As part of the product development and validation process Gooding Aluminium Ltd required a programme of testing to establish the mode of failure of the Shuffle-Less glazing channels when installed with a glass infill.

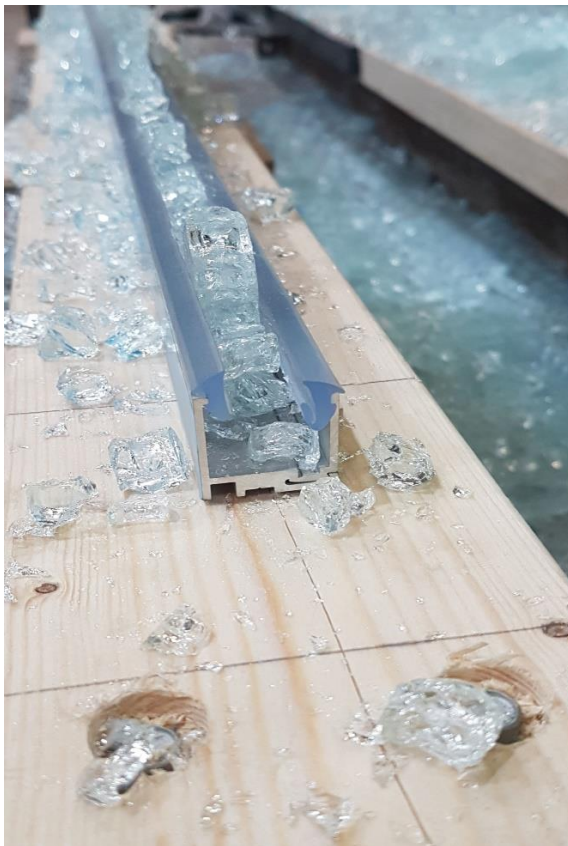
Photograph of GA's Shuffle-Less glazing channel and clear beading (wedge) still securely in position, unaffected by the impact energy of the weighted bag in Lucideon Test No. 181406 (QT-49734/1/GMB)/Ref. 1/Supp1

N.B. The above image was taken at the test site by a GA representative and has been added to this document for clarification (it was not included in the original test report).

N.B. On completion of Test 3, the Shuffle-Less glazing channel and clear beading (wedge) were still securely in position, unaffected by the impact energy of the weighted bag. Please see page 2 for visual evidence.
